INVESTIGATION OF FALL PROTECTION FOR
RESIDENTIAL ROOF CONSTRUCTION AND REPAIR IN HAWAII

A THESIS SUBMITTED TO THE GRADUATE DIVISION OF THE UNIVERSITY
OF HAWAII IN PARTIAL FULFILLMENT OF THE
REQUIREMENTS FOR THE DEGREE OF

CIVIL ENGINEERING

AUGUST 1997

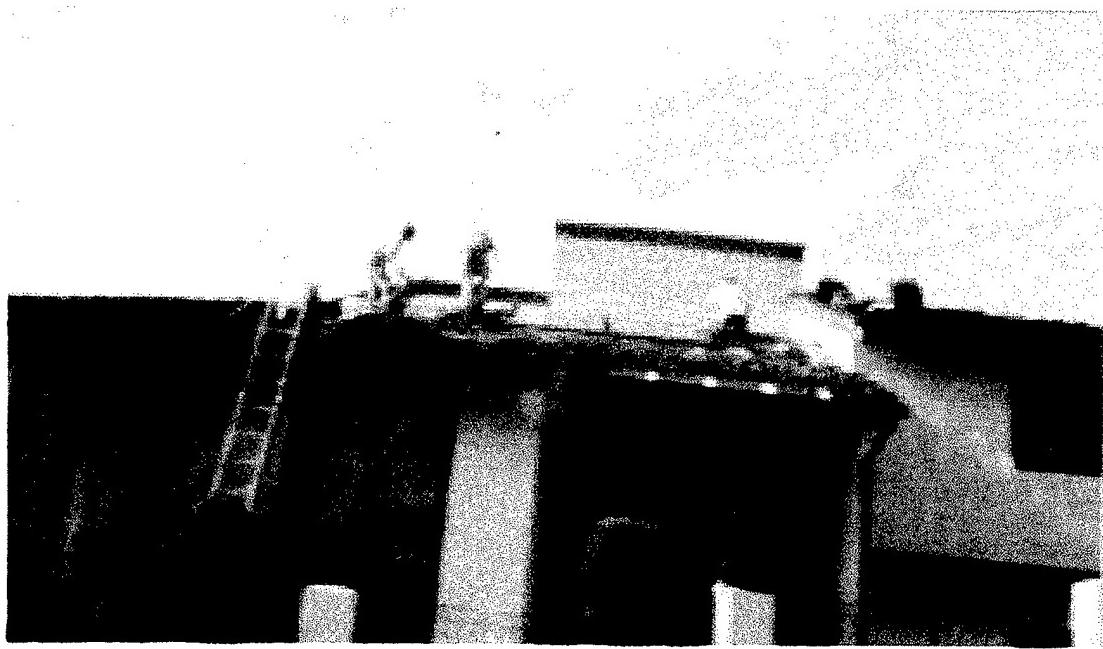
Figure B.1: Partial reroofing project, Aiea; no protection in use

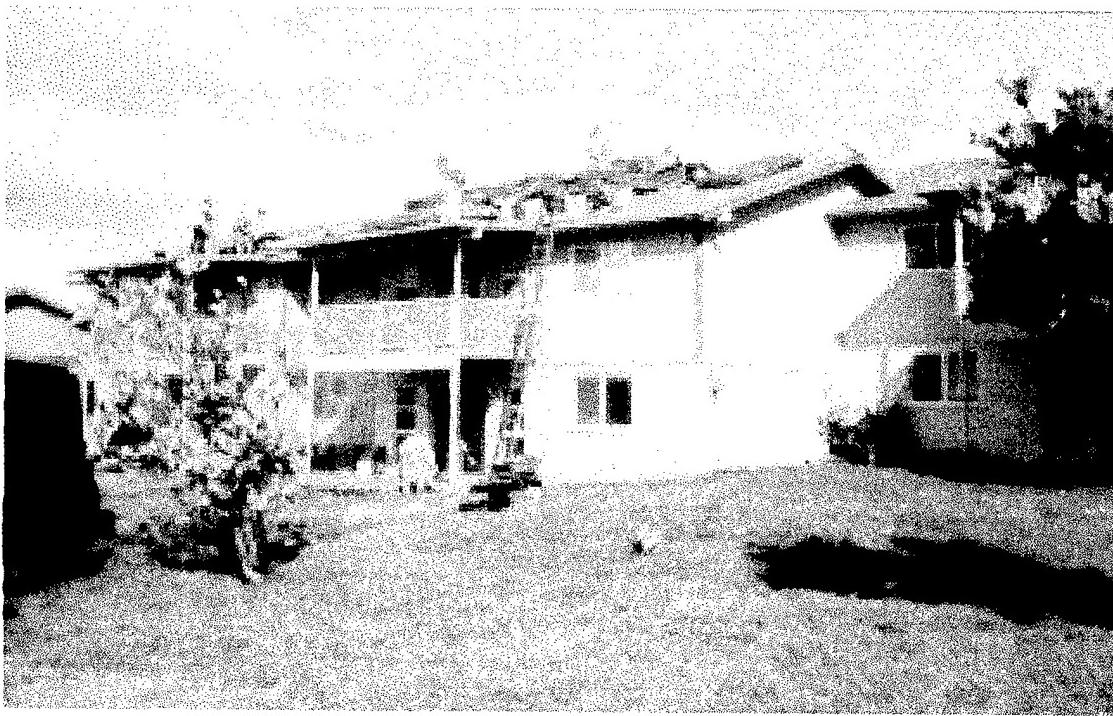
Figure B.2: Reroofing job, Marine Corps Base Hawaii, Kaneohe; PFAS in use

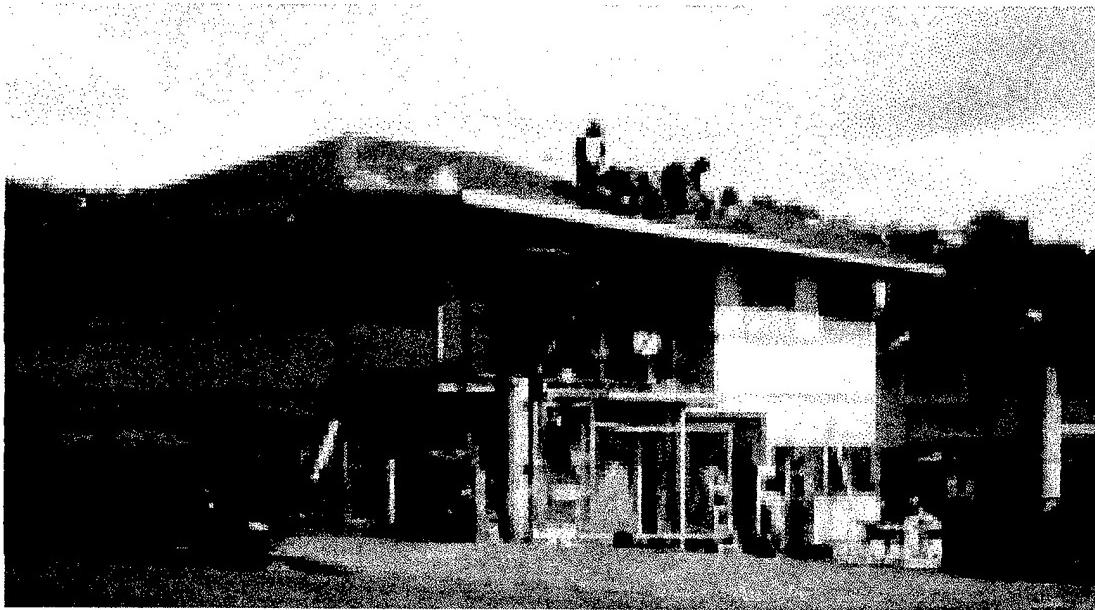
Figure B.4: Renovation project, Honolulu; no protection

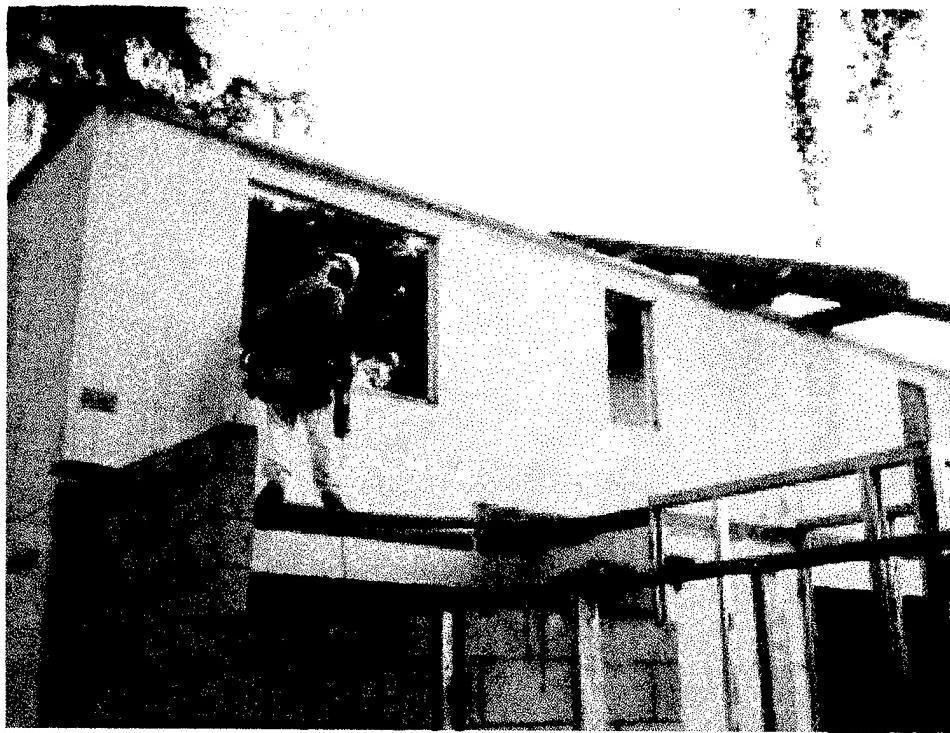
Figure B.8: Renovation project, Hickam Air Force Base; fall protection plan (Note improper work platform and lack of fall protection.)

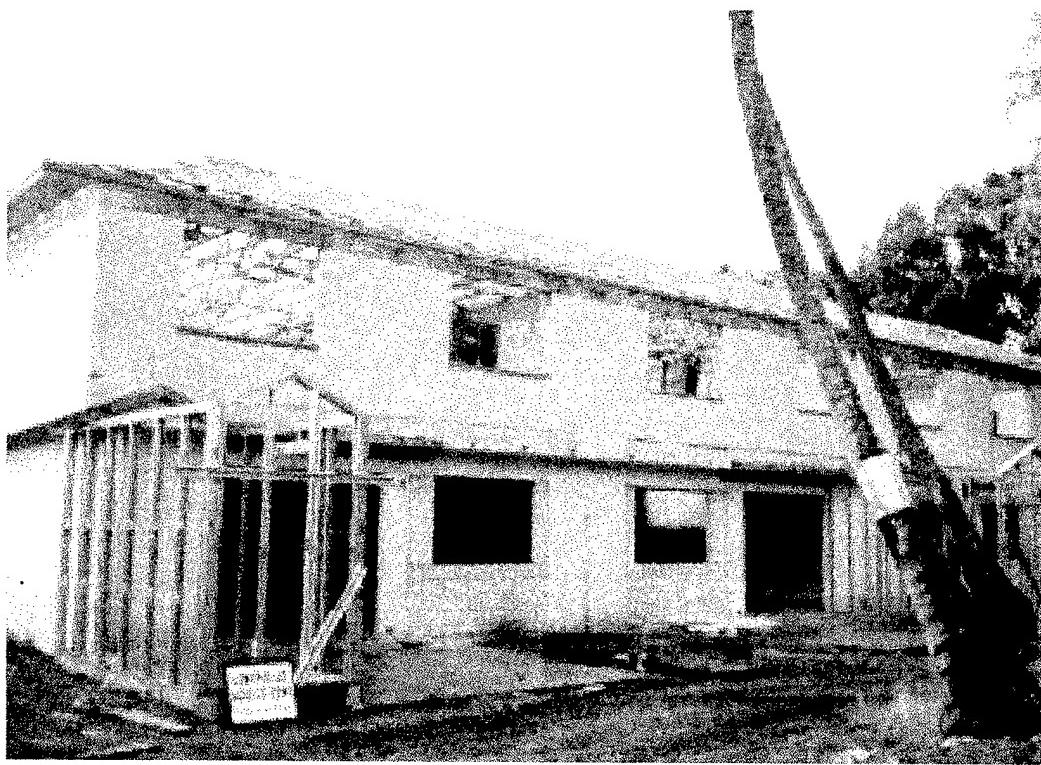
Figure B.9: Renovation project, Hickam Air Force Base; fall protection plan (Note "controlled access zone" sign at left front corner of structure.)

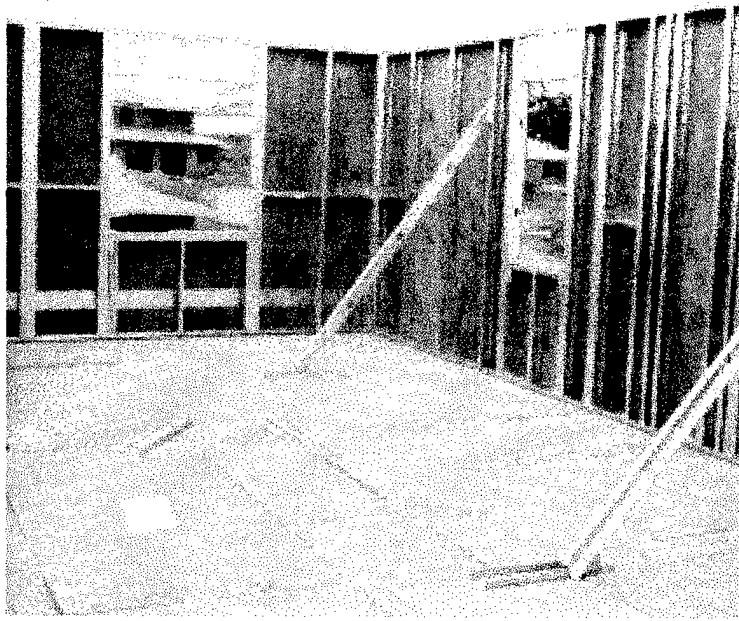
Figure B.14: New construction, Moanalua Navy Family Housing, Pearl Harbor; use of alternative construction sequence to allow for placement of work platforms during truss installation (Note lack of interior frame walls.)

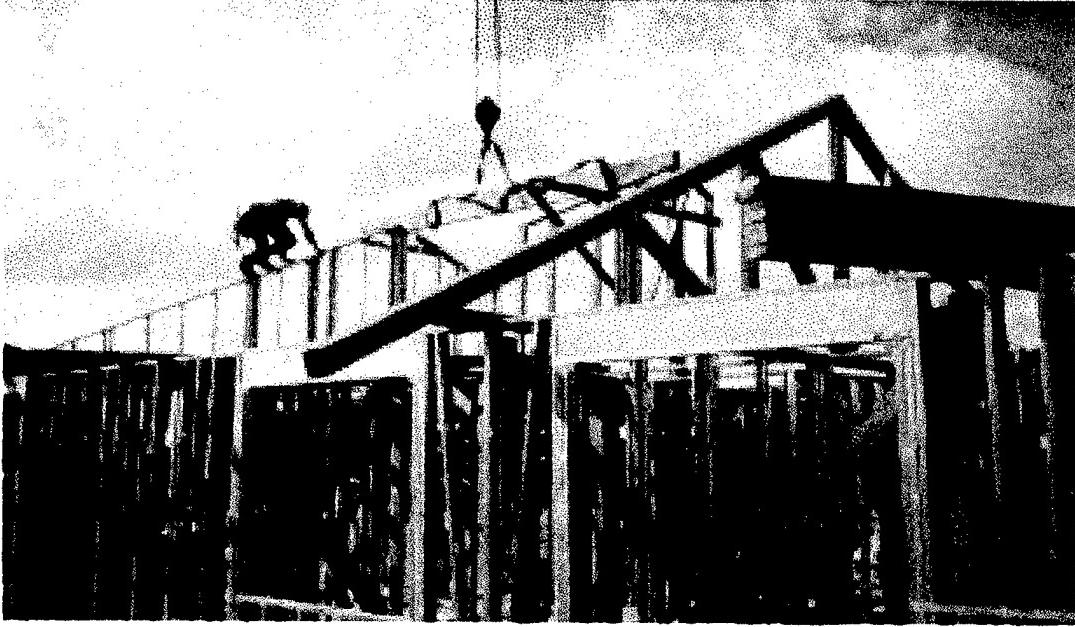
Figure B.18: New construction, central Oahu; fall protection plan; setting the center ridge for half-truss installation (No protection is afforded to the worker.)

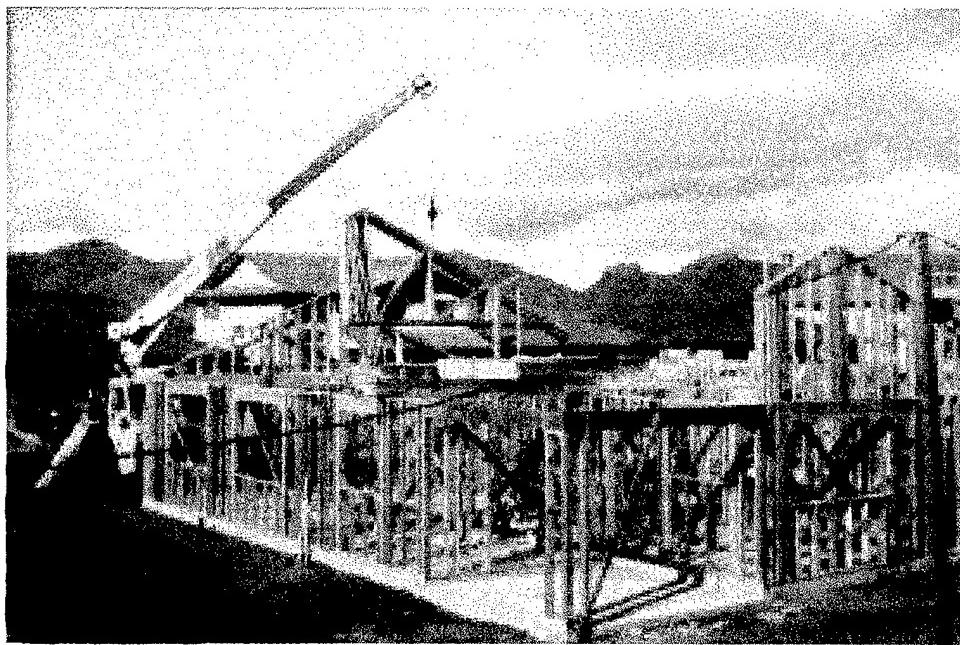
Figure B.19: New construction, central Oahu; fall protection plan; truss delivery and placement on the top plates of frame walls (No protection is afforded to the worker.)

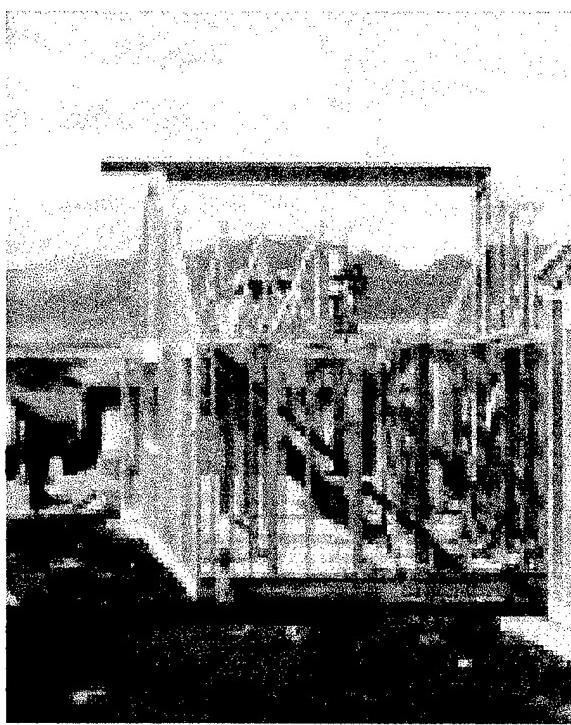
Figure B.21: New construction, central Oahu; fall protection plan; truss installation--setting the trusses

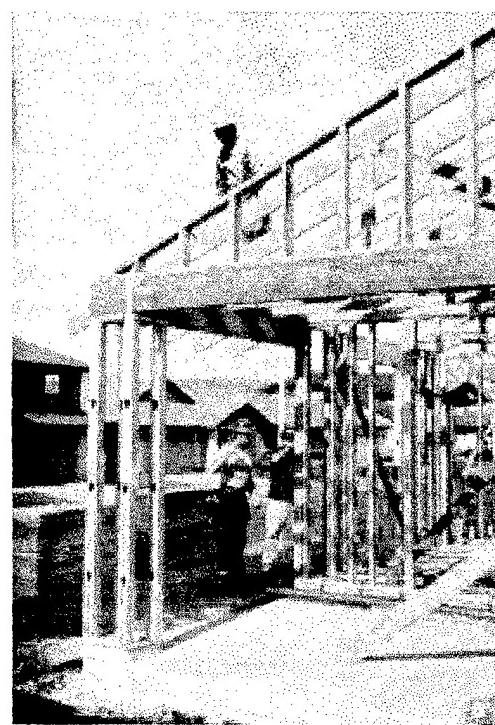
Figure B.22: New construction, central Oahu; fall protection plan; truss installation--walking the top plate
